WIGWAM LAKE DAM

NDI ID NO. PA-00990

PHASE I INSPECTION REPORT
NATIONAL DAM INSPECTION PROGRAM

MAY 1981

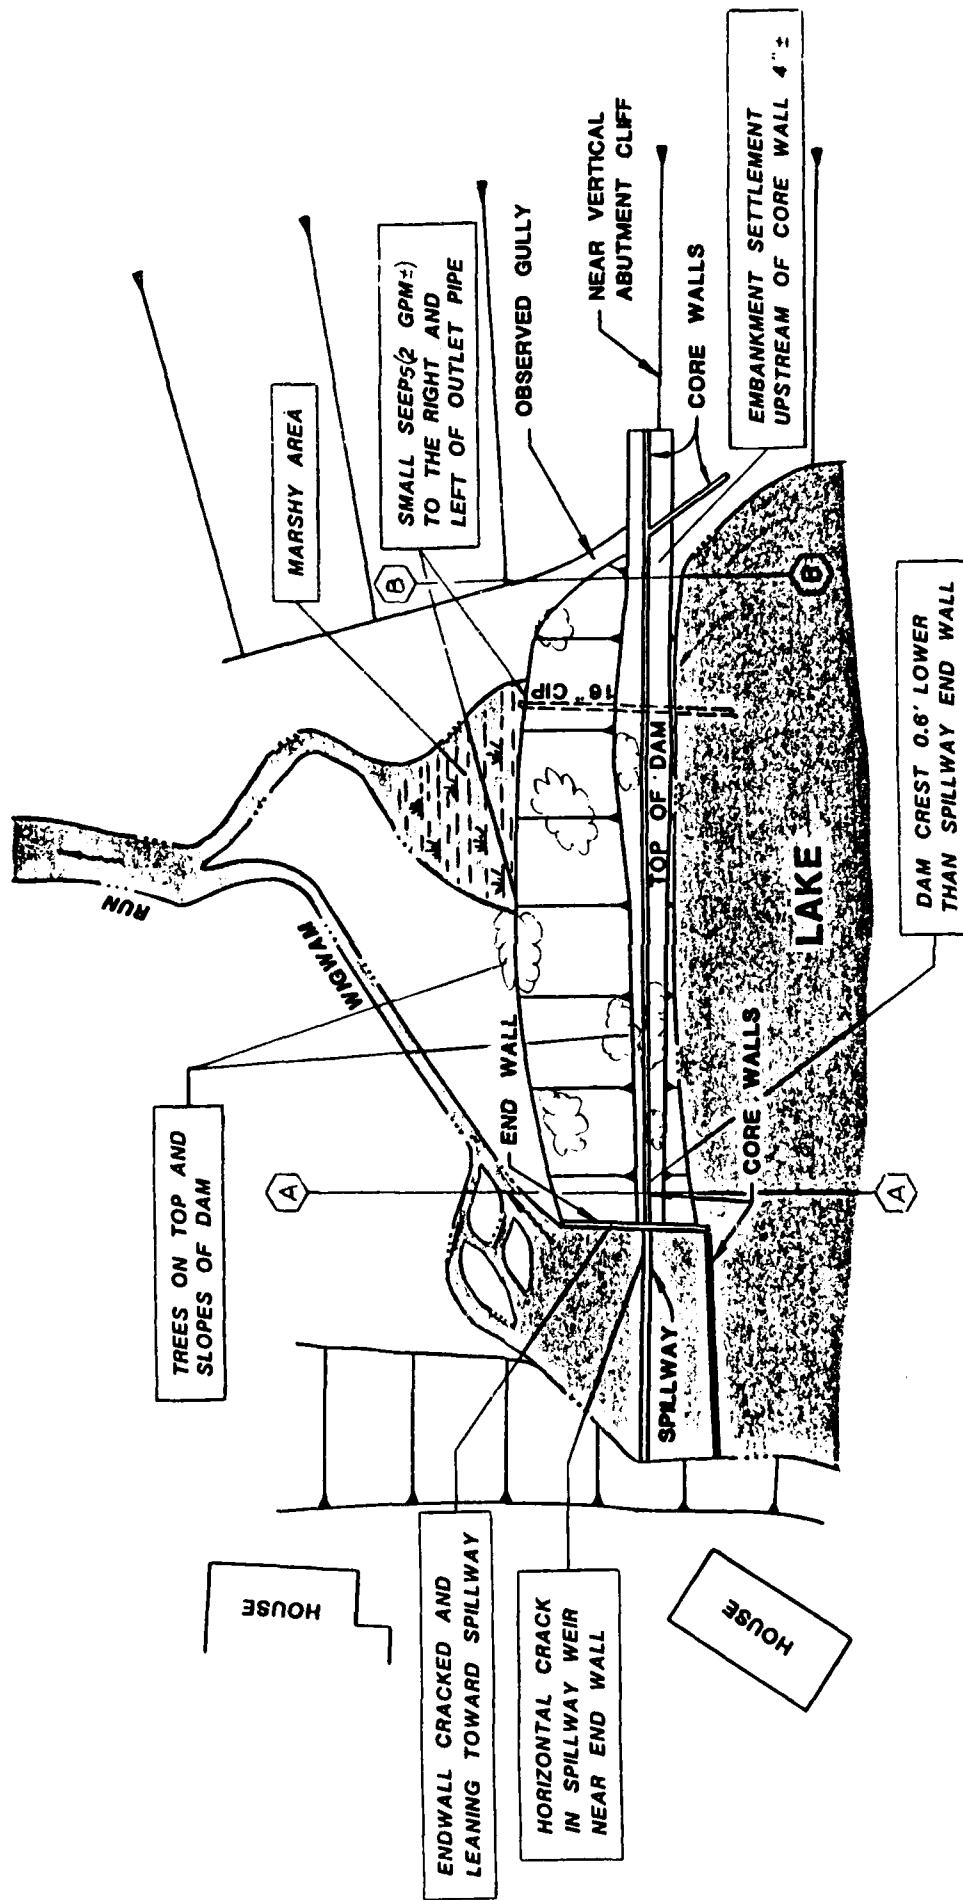
WIGWAM LAKE DAM
GENERAL PLAN - FIELD INSPECTION NOTES

(a) General. The overall appearance of the dam and its appurtenant structures is considered to be poor. The locations of observed deficiencies are shown on the Sketch Plan, presented in Exhibit A-1, Appendix A. The profile and typical sections of the dam are presented in Exhibits A-2, A-3, and A-4 and are based on field survey made on the day of inspection. The survey datum for this inspection was an approximate elevation obtained for the spillway crest from a USGS map. The construction drawings for the dam and appurtenant structures are shown in Exhibits E-2 and E-3, Appendix E. The elevations shown on the construction drawings are based on a different datum than that of the USGS map. Therefore, to convert the elevations shown on the appended construction drawings to the elevations used in this report, it is necessary to add 609 feet to the elevations shown on the appended drawings. On the inspection date (11/26/80), the lake level was 0.1 foot above the spillway crest (elevation 708 above mean sea level). Deficiencies observed during the field inspection are described below, and further illustrated in Exhibits A-1, Appendix A. Visible features of the dam are depicted in photographs, presented in Appendix C.
